# CONSERVATION TREATMENT FINAL REPORT

## MOUNT OLIVE CEMETERY

Jackson State University  
Jackson, Hinds County, Mississippi

February 21, 2024

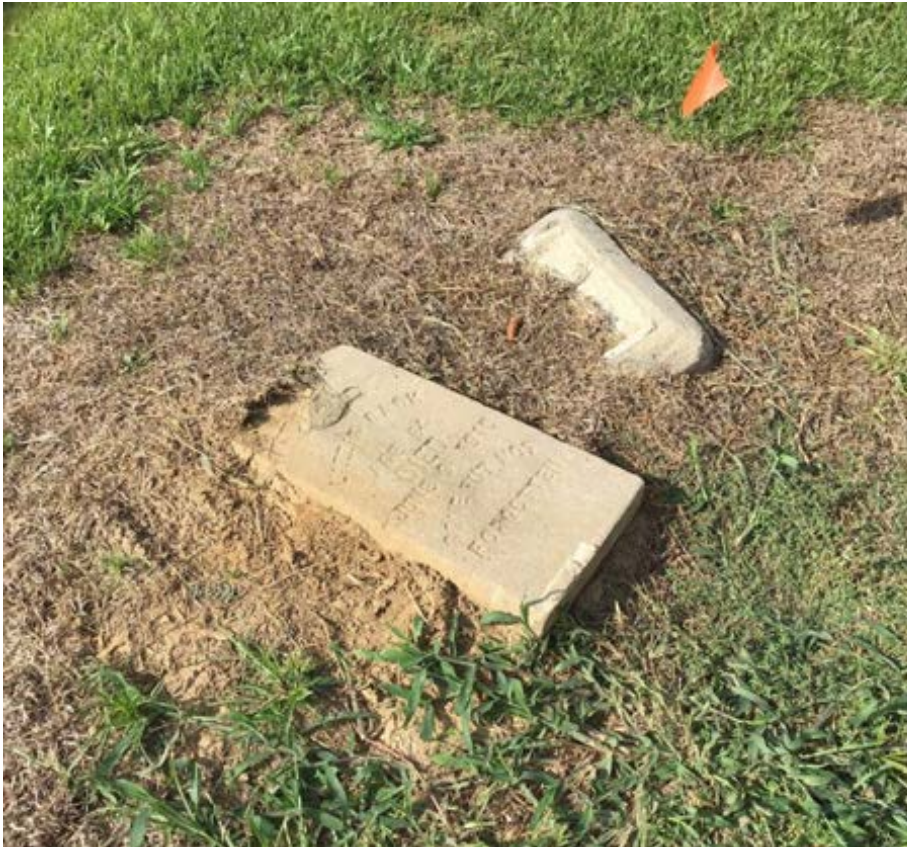
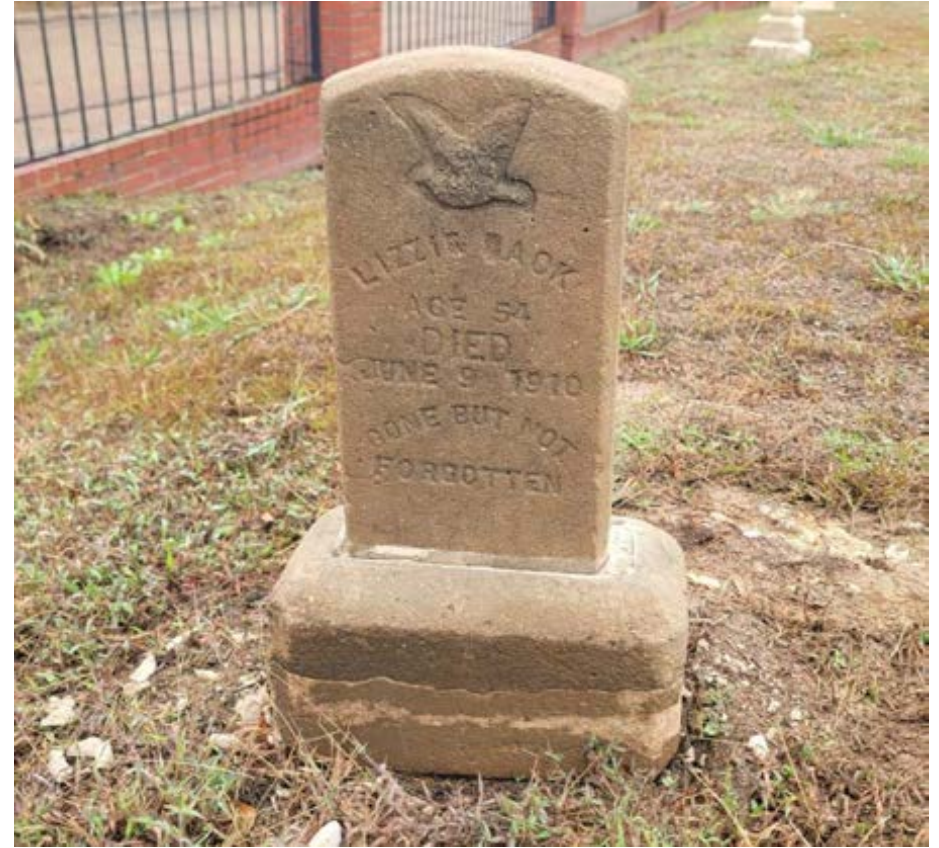
### **Conservation Treatment for Lizzie Back**

After excavating the concrete die and base by digging a shallow trench at each elevation, RGA determined that the base was broken into two pieces. The broken pieces of the base were joined using small dabs of the epoxy-bonding agent Akemi Akepox stone structural epoxy.

RGA's conservation team leveled the socketed base with a mixture of crushed rock and sand. Resetting/leveling this base involves setting it on a compacted bed of crushed rock and sand, backfilling, and tamping the crushed rock and sand, and replacing and tamping the topsoil removed during excavation. The use of crushed rock and sand for leveling is preferential to concrete because concrete is much harder than the original stone type, and the mixture of crushed rock and sand helps maintain drainage away from the gravemarker.

RGA cleaned the die and base with no psi water and a soft, wet brush. Conservation work included the cleaning/treating of both the die and socketed base with Orvus WA Paste (a non-ionic detergent) and D/2 Biological Solution to remove atmospheric staining and biological growth, respectively.

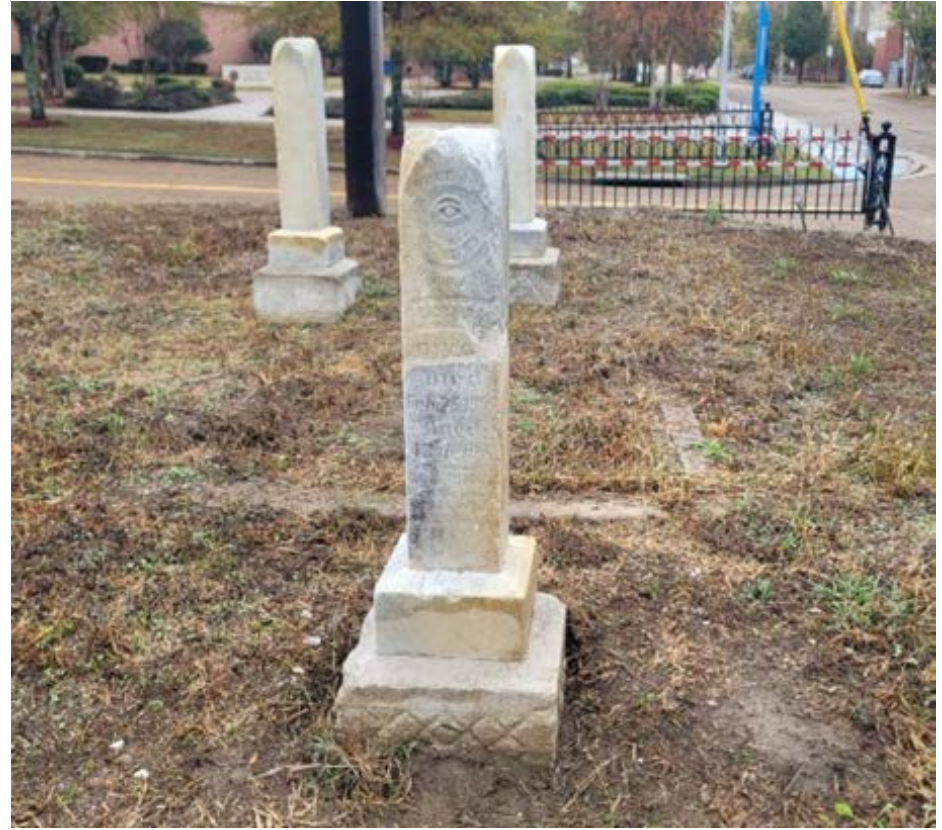
### **Conservation Treatment for Peter Dixon**

RGA's conservation team relocated the stacked bases and broken shaft to area adjacent to the burial plot and place them on padded supports where they can be properly assessed and cleaned. The lowest base was leveled on a mixture of crushed rock and sand. Resetting/leveling requires excavating to the bottom of the gravemarker, straightening the base to vertical, backfilling and tamping the crushed rock and sand, and replacing and tamping the topsoil removed during excavation. The use of crushed rock and sand for leveling is preferential to concrete because concrete is much harder than the original stone type, and the mixture of crushed rock and sand helps maintain drainage away from the gravemarker.

RGA cleaned this marble pedestal tomb and stacked bases with no psi water and a soft, wet brush. Conservation work included the cleaning/treating all components with Orvus WA Paste (a non-ionic detergent) and D/2 Biological Solution to remove atmospheric staining and biological growth, respectively.

Degraded, failed structural mortar was removed with small hand tools such as stone and wood chisels and metal mallets. The shaft and stacked bases were joined using lead wedges placed in each corner, small dabs of the epoxy-bonding agent Akemi Akepox stone structural epoxy, and Limeworks.us Ecologic Natural Hydraulic Lime 3.5 (NHL), non-pigmented repair mortar.

Each component (stacked bases and shaft) was lifted using a wood clamp system operated by two people.
